# **ASBESTOS MANAGEMENT SURVEY REPORT**

**HOME FROM HOME**

**20 Church Street, Stratton St Margaret, Swindon, SN3 4NB**

**202802-959352**

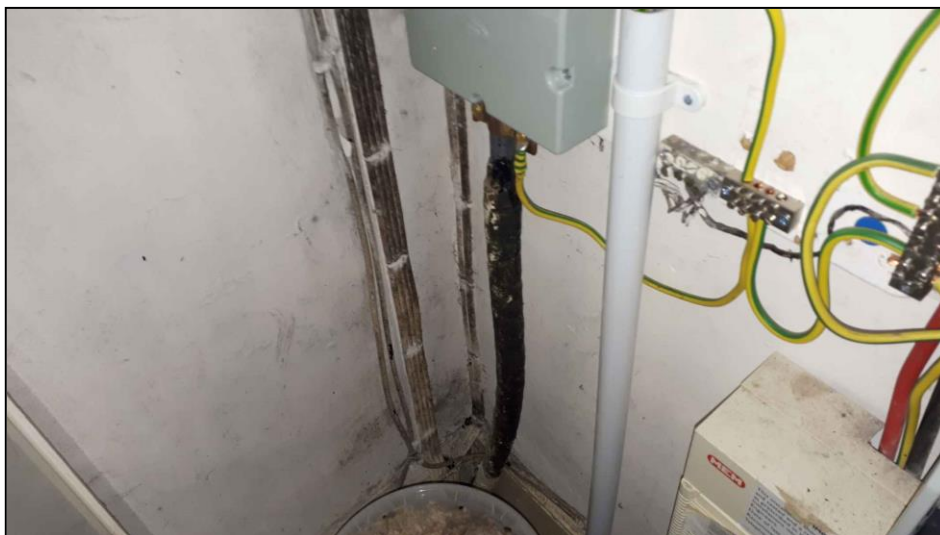
| <b>Site Address:</b> | 20 Church Street, Stratton St<br>Margaret, Swindon, SN3 4NB | <b>Area Description:</b> | Electrical Cupboard |
| <b>Building:</b> | . | <b>Material Description:</b> | Cable wrap |

| <b>Material Risk:</b> | <b>5</b> |
| Asbestos Type: | 1 - Chrysotile |
| Product Type: | 2 - AIB, Millboard, gaskets, paper etc |
| Extent of Damage: | 1 - Low damage |
| Surface Treatment: | 1 - Enclosed sprays and lagging, AIB, AC sheets etc |

| Comments: | Presumption Reason: live electric |

Timescale for Recommendation : 12 months

| Recommendation: | Manage |

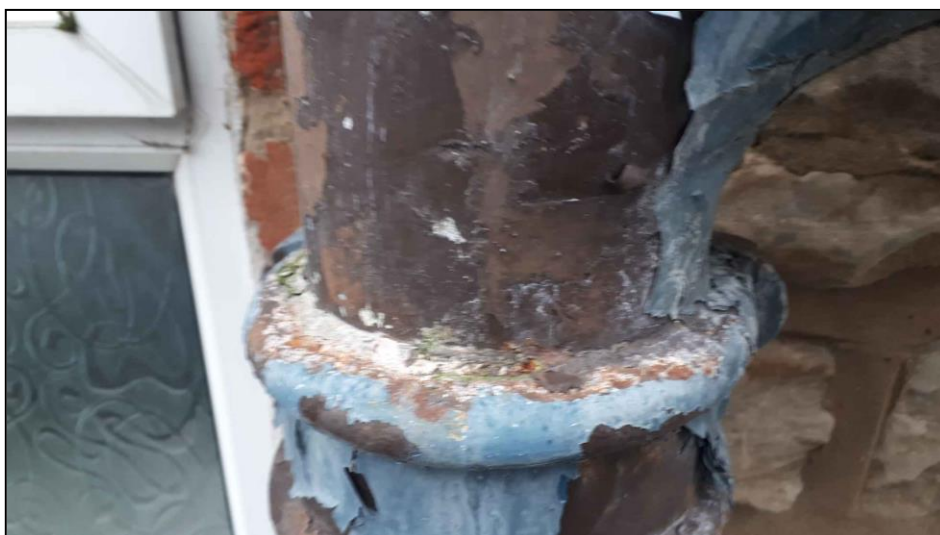
| <b>Building:</b> | . | <b>Material Description:</b> | Putty to soil stack |

| <b>Material Risk:</b> | 4 |
| Asbestos Type: | 2 - Amosite/other amphiboles (not Crocidolite) and Chrysotile |
| Product Type: | 1 - Asbestos composites, decorative finishes, AC |
| Extent of Damage: | 1 - Low damage |
| Surface Treatment: | 0 - Composite materials containing asbestos (reinforced plastics, vinyl, etc) |

| SOCOTEC<br>Asbestos<br>SAMPLE No | CLIENT<br>SAMPLE<br>No | SAMPLE LOCATION & DESCRIPTION* | FIBRE TYPE<br>DETECTED | ANALYSIS No |
|---|---|---|---|---|
| 001 | | External Floor - External EXT - Putty to soil stack | CHRYSTOTILE,<br>AMOSITE | 202802-959352-0001-<br>001 |

Timescale for Recommendation : 12 months

Recommendation: Manage

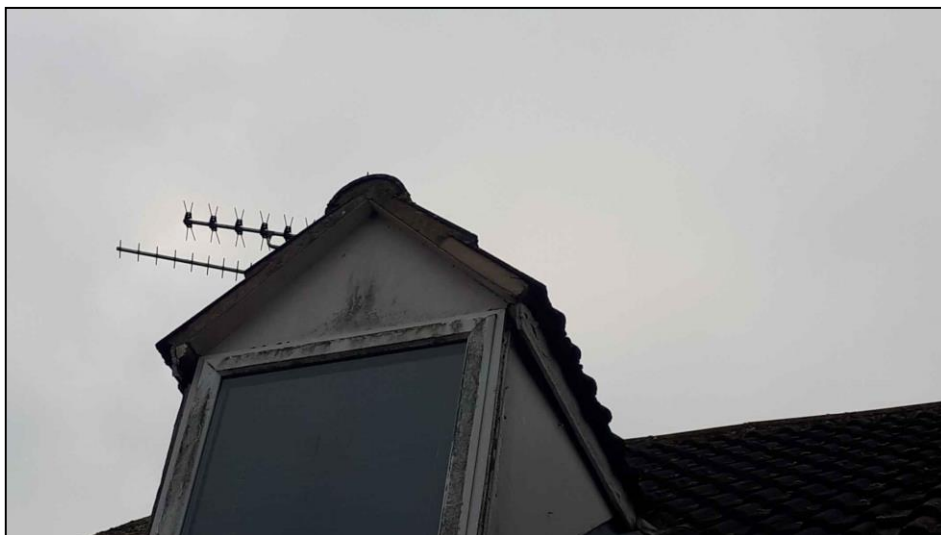
| <b>Building:</b> | . | <b>Material Description:</b> | Cement verge undercloaking to<br>rear dorma windows |

| <b>Material Risk:</b> | <b>3</b> |
| Asbestos Type: | 1 - Chrysotile |
| Product Type: | 1 - Asbestos composites, decorative finishes, AC |
| Extent of Damage: | 0 - Good |
| Surface Treatment: | 1 - Enclosed sprays and lagging, AIB, AC sheets etc |

| Comments: | Presumption Reason: too high to access |

Timescale for Recommendation : 12 months

| Recommendation: | Manage |
