### BUILDING CONDITION REPORT

### PLANNED AND REACTIVE (CYCLICAL) MAINTENANCE SCHEDULE

**DUDLEY HOUSE  
28 HIGH STREET  
WOOTTON BASSETT  
WILTSHIRE  
SN4 7AF**

Report Date: 4 July 2021

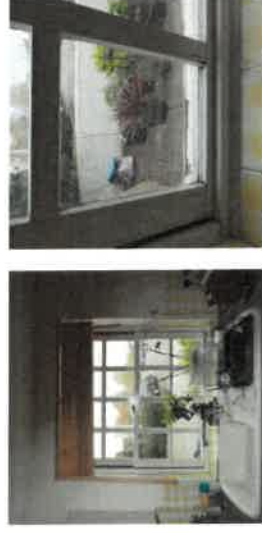
Kitchen window requires competent repair  
subject to consultation and application on suitability
