## **Accolade Asbestos Services**

**Wesley Court,  
Wotton Bassett**

***Appendix One – Data Summary sheet and Asbestos Register***

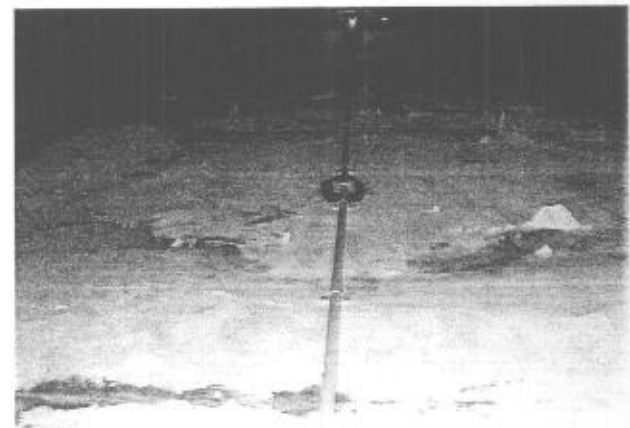
Site: Wesley Court, Wotton Bassett  
 Detail sheet - Unique sample ref number: CD712

| SAMPLE /<br>VISUAL<br>REF. | CD712 | G | Refuse Room | Ceiling coating | 14m <sup>2</sup> | NAD | 0 |

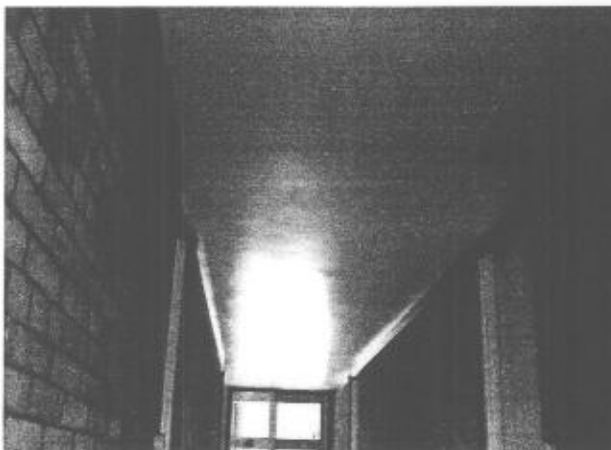
Site: Wesley Court, Wotton Bassett.  
Detail sheet - Unique sample ref number: CD713

| SAMPLE /<br>VISUAL<br>REF. | FLOOR/<br>LEVEL | Location | DESCRIPTION | APPROX<br>EXTENT | ANALYSIS<br>RESULT | TOTAL<br>M.A.S |
|---|---|---|---|---|---|---|
| CD713 | All | All Corridors | Vinyl Floor Covering | 1m <sup>2</sup> | NAD | 0 |

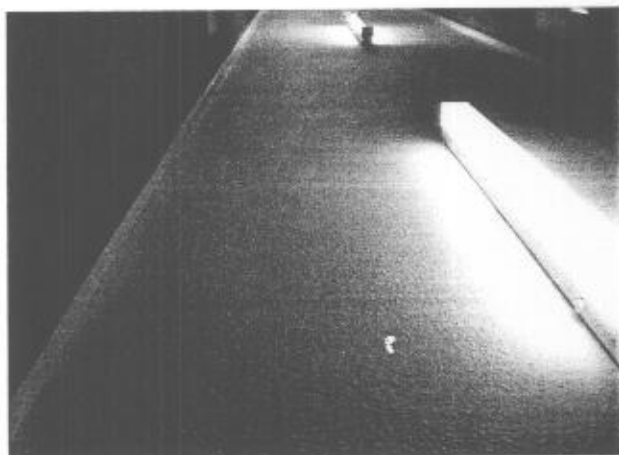
Detail sheet - Unique sample ref number: CD714

| SAMPLE /<br>VISUAL<br>REF. | FLOOR/<br>LEVEL | Location | DESCRIPTION | APPROX<br>EXTENT | ANALYSIS<br>RESULT | TOTAL<br>M.A.S |
|---|---|---|---|---|---|---|
| CD714 | G | Corridors Ground Floor | Arlex to ceiling | 60m <sup>2</sup> | Chrysotile | 2 |

| ACTION | RECOMMENDATION |
|---|---|
| Leave & Label | ✓ |

| TIMESCALE | RECOMMENDATION |
|---|---|
| Immediate | ✓ |

| TIMESCALE | RECOMMENDATION |
|---|---|
| 12 Months | ✓ |

- Do not carry out any work or activity, which is liable to disturb this material (e.g.sanding, drilling, fixing to, painting, maintenance of or removal). It is advised that a licensed contractor is employed to under take any work which may involve the disturbance of this material

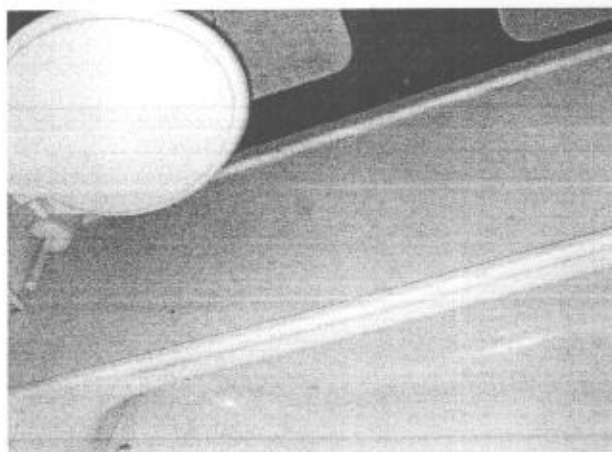
| SAMPLE /<br>VISUAL<br>REF. | CD715 | G | Bathroom | Bath Panel | 3m <sup>2</sup> | Chrysotile | 2 |

| ACTION | RECOMMENDATION |
|---|---|
| Leave & Label | ✓ |

| TIMESCALE | RECOMMENDATION |
|---|---|
| Immediate | ✓ |

| TIMESCALE | RECOMMENDATION |
|---|---|
| 12 Months | ✓ |

- Do not carry out any work or activity, which is liable to disturb this material (e.g. sanding, drilling, fixing to, painting, maintenance of or removal). It is advised that a licensed contractor is employed to undertake any work which may involve the disturbance of this material.

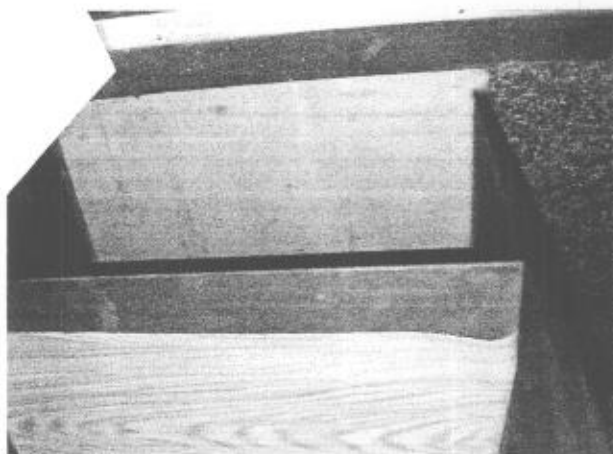
Site: 1 Wesley Court, Wotton Bassett.  
Detail sheet - Unique sample ref number: CD717

| SAMPLE /<br>VISUAL<br>REF. | FLOOR/<br>LEVEL | Location | DESCRIPTION | APPROX<br>EXTENT | ANALYSIS<br>RESULT | TOTAL<br>M.A.S |
|---|---|---|---|---|---|---|
| CD717 | G | Bedroom 1 | Floor Tiles in Cup'd | 4m <sup>2</sup> | Chrysotile | 2 |

| ACTION | RECOMMENDATION |
|---|---|
| Leave & Label | ✓ |

| TIMESCALE | RECOMMENDATION |
|---|---|
| Immediate | ✓ |

| TIMESCALE | RECOMMENDATION |
|---|---|
| 12 Months | ✓ |

1. Do not carry out any work or activity, which is liable to disturb this material (e.g. sanding, drilling, fixing to, painting, maintenance of or removal).

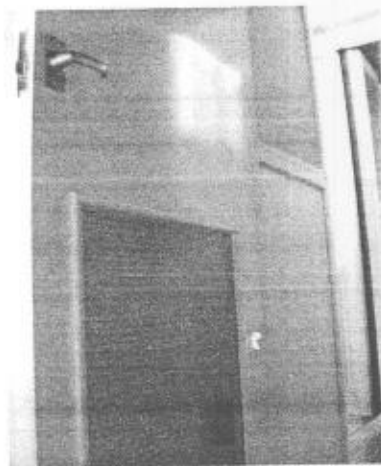
| SAMPLE /<br>VISUAL<br>REF. | CD822 | 2 | Living Room | Fire Doors | 2m <sup>2</sup> | Amosite<br>(assumed) | 5 |

| ACTION | RECOMMENDATION |
|---|---|
| Leave & Label | ✓ |

| TIMESCALE | RECOMMENDATION |
|---|---|
| Within 3 months | ✓ |

| TIMESCALE | RECOMMENDATION |
|---|---|
| 12 Months | ✓ |

1. If the door becomes damaged to expose any internal material carry out an asbestos test before undertaking and repair work.

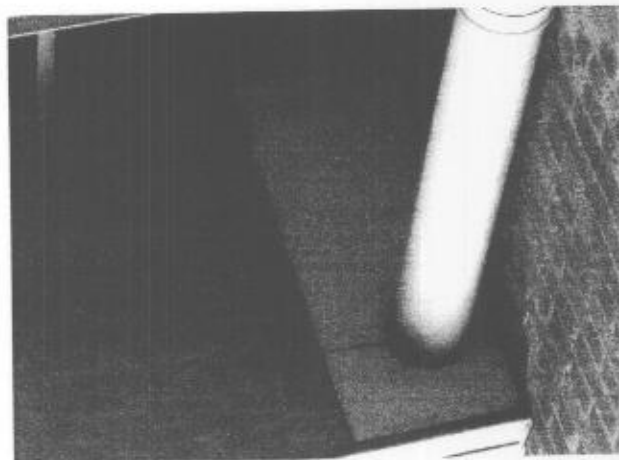
| SAMPLE /<br>VISUAL<br>REF. | FLOOR/<br>LEVEL | Location | DESCRIPTION | APPROX<br>EXTENT | ANALYSIS<br>RESULT | TOTAL<br>M.A.S |
|---|---|---|---|---|---|---|
| CD721 | 2 | Roof | Asbestos insulation boards around Rain<br>water pipes both ends of building. | 2m <sup>2</sup> | Amosite | 6 |

| ACTION | RECOMMENDATION |
|---|---|
| Encapsulate & Label | ✓ |

| TIMESCALE | RECOMMENDATION |
|---|---|
| Within 3 months | ✓ |

| TIMESCALE | RECOMMENDATION |
|---|---|
| 6 Months | ✓ |

1. Do not carry out any work or activity, which is liable to disturb this material (e.g. sanding, drilling, fixing to, painting, maintenance of or removal). It is advised that a licensed contractor is employed to under take any work which may involve the disturbance of this material

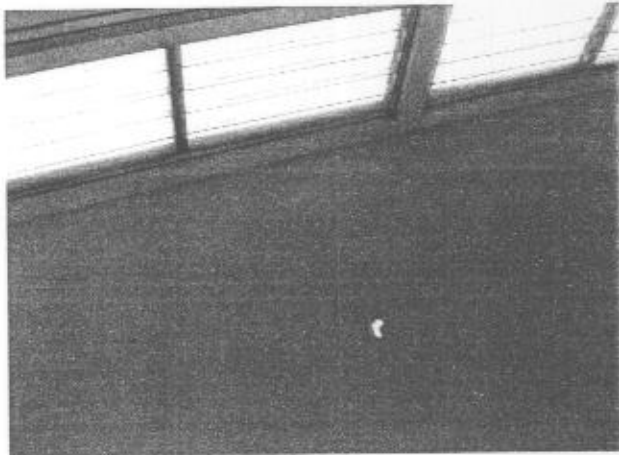
Site: Wesley Court, Wotton Bassett.  
 Detail sheet - Unique sample ref number: CD724

| SAMPLE /<br>VISUAL<br>REF. | CD724 | 2 | Sky Light | Coating to underside of sky light | 4m <sup>2</sup> | NAD | 0 |

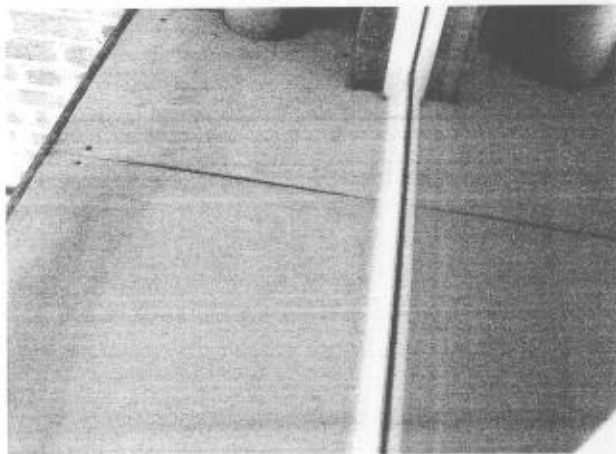
| SAMPLE /<br>VISUAL<br>REF. | CD725 | 2 | Roof | Soffits | 30m² | Chrysotile<br>Amosite | 5 |

| ACTION | RECOMMENDATION |
|---|---|
| Leave & Label | ✓ |

| TIMESCALE | RECOMMENDATION |
|---|---|
| Immediate | ✓ |

| TIMESCALE | RECOMMENDATION |
|---|---|
| 12 Months | ✓ |

1. Do not carry out any work or activity, which is liable to disturb this material (e.g. sanding, drilling, fixing to, painting, maintenance of or removal).  
 It is advised that a licensed contractor is employed to under take any work which may involve the disturbance of this material
