Fire Safety Management Plan

Fire Risk Assessment

**Flats 1 – 30
Wesley Court
Longfellow Crescent
Wootton Bassett
SN4 8JZ**

Dated: 26th September 2024

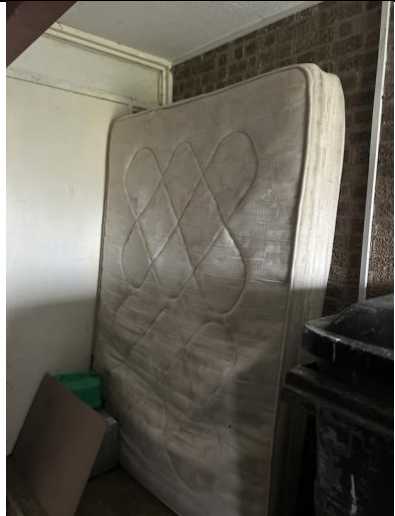
No	Significant Findings & Required Action	Priorities	Timescale	Photo
3	The RP must ensure that the mattress and the empty petrol fuel can in the bin store are removed. And the leaseholders/residents are informed they must not store/leave such items in this area.	3	B

13.0	Housekeeping	Yes	No	N/A
13.1	Is the standard of housekeeping adequate?		X	
13.2	More Specifically:			
	a) Do combustible materials appear to be separated from ignition sources?	✓		
	b) Is unnecessary accumulation or inappropriate storage of combustible materials or waste avoided?		X	
	c) Are gas and electricity intake/meter cupboards adequately secured and kept clear of combustible materials?			✓
13.3	Comments and hazard observations:			
	<ul style="list-style-type: none"> The RP must ensure that the mattress and the petrol fuel can in the bin store are removed. And the leaseholders/residents are informed they must not store/leave such items in this area.

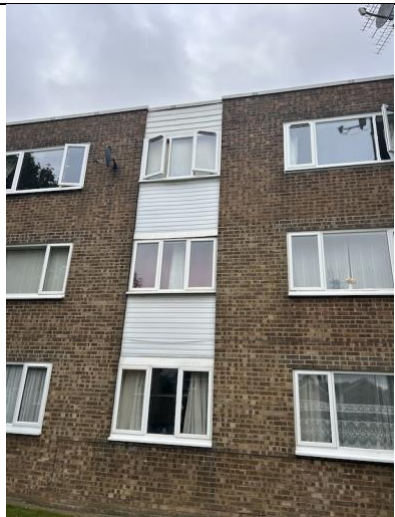
Action required		
4	The external facade for this block in certain areas is a type of uPVC type cladding, which at the time of the Assessment it could not be identified if it was a suitable installation and compliant with Building Regulations. Whilst this is low risk due to the height of this block of flats being less than 18 metres. This external surface area should still be compliant with fire barriers fitted to windows where necessary as part of the installation. The RP should ensure that this external wall cladding installation is fit for purpose and further assessment is completed by a competent person of these areas.	3	D

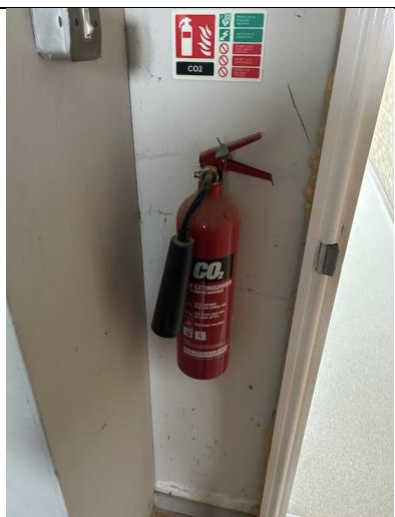
Action required		
5	There are two 2KG CO ² fire extinguishers within Landlords storerooms. If they remain, the RP should also ensure that at each fire point there are also one x 13A fire rated fire extinguisher too for Class A type fires. It in the opinion of the Assessor that these two 2KG CO ² fire extinguishers should be removed.	3	B

22.0	Manual Fire Extinguishing Appliances		
	Yes	No	N/A
22.1	Reasonable provision of portable fire extinguishers?		
		X	
22.2	Are all fire extinguishing appliances readily accessible?		
	✓		
22.3	Comments and deficiencies observed:		
	<ul style="list-style-type: none"> There are two 2KG CO² fire extinguishers within Landlords storerooms. If they remain, the RP should also ensure that at each fire point there are also one x 13A fire rated fire extinguisher too for Class A type fires. It is the opinion of the Assessor that these two 2KG CO² fire extinguishers should be removed.

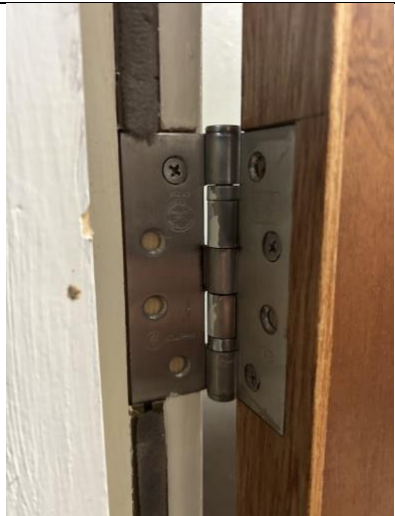
No	Significant Findings & Required Action	Priorities	Timescale	Photo
6	The RP must ensure that all fire doors are fit for purpose, which open onto the means of escape. The two fire doors, which were inspected (Flats 16 & 22 entrance doors) are not fit for purpose and require attention. Plus, the Assessor noted on common area fire doors, where intumescent strips had not been installed, fire doors fall foul the floor, non-fire rated door locks in new fire doors, screws missing in hinges or large gaps between door leaf, floor or doorframe. The Assessor was advised that DSD Build installed the common area fire doors. And they should contact them and raise these issues, once all common area fire doors have had their annual inspection. The RP must ensure that each flat entrance fire doors and common area fire doors are inspected every 12 months in accordance with BS 8214:2016, manufactures instructions and Regulation 10 under the Fire Safety (England) Regulation 2022. Fire Safety Services have completed fire door inspections of Flats 16 & 22 entrance door fire doors, which both require attention. The RP must ensure that they notify all residents of the condition of the fire doors, and advise the freeholder/leaseholders that their flat entrance and common area fire doors must be inspected and be a FD30S fire door and fit for purpose. Plus, the RP and the leaseholders, where necessary, must ensure the fire door remediations works within the reports are completed within a defined timeframe, and all fire doors are fit for purpose. Which was not the case at the time of the Assessment, and some would not perform as intended.	O-2	B

- The RP must ensure that all fire doors are fit for purpose, which open onto the means of escape. The two fire doors, which were inspected (Flats 16 & 22 entrance doors) are not fit for purpose and require attention. Plus, the Assessor noted on common area fire doors, where intumescent strips had not been installed, fire doors fall foul the floor, non-fire rated door locks in new fire doors, screws missing in hinges or large gaps between door leaf, floor or doorframe. The Assessor was advised that DSD Build installed the common area fire doors. And they should contact them and raise these issues, once all common area fire doors have had their annual inspection. The RP must ensure that each flat entrance fire doors and common area fire doors are inspected every 12 months in accordance with BS 8214:2016, manufactures instructions and Regulation 10 under the Fire Safety (England) Regulation 2022. Fire Safety Services have completed fire door inspections of Flats 16 & 22 entrance door fire doors, which both require attention. The RP must ensure that they notify all residents of the condition of the fire doors, and advise the freeholder/leaseholders that their flat entrance and common area fire doors must be inspected and be a FD30S fire door and fit for purpose. Plus, the RP and the leaseholders, where necessary, must ensure the fire door remediations works within the reports are completed within a defined timeframe, and all fire doors are fit for purpose. Which was not the case at the time of the Assessment, and some would not perform as intended.

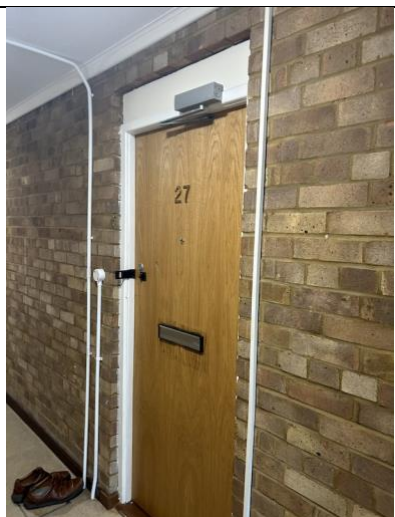
Action required & Ongoing maintenance		
7	The Assessor noted that Flat 27 has a hasp and clasp on the outside of their door, which is for further security when they leave their flat. However, there is a risk when the flat is occupied the clasp could be closed, either by accident or on purpose by someone. Which could prevent the door being opened from the inside, especially if they are frail or vulnerable. The RP should advise the occupants of this flat to remove this hasp and clasp.	3	A

- The Assessor noted that Flat 27 has a hasp and clasp on the outside of their door, which is for further security when they leave their flat. However, there is a risk when the flat is occupied the clasp could be closed, either by accident or on purpose by someone. Which could prevent the door being opened from the inside, especially if they are frail or vulnerable. The RP should advise the occupants of this flat to remove this hasp and clasp.

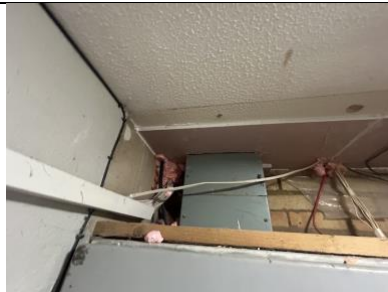
No	Significant Findings & Required Action	Priorities	Timescale	Photo
8	At the time of the Assessment the Assessor assessed various areas to ensure that the fire compartmentation was adequate and fit for purpose. However, the Assessor noted where cables pass through a ceiling (fire resisting construction) which had not been adequately fire stopped above the main electrical intake within the storerooms. Due to the building being flats, it places greater importance on ensuring that the fire resisting construction / compartments have not been compromised and are fit for purpose. Please note that pink/yellow or blue expanding foam is not deemed fit for purpose. The RP must ensure that a competent person fire stops these areas with the correct fire rated product. Please note that when a contractor carries out any work the RP should ensure that they receive a certificate of conformity of the type of products used. Please note that the current product in use (pink expanding foam) would be deemed not fit for purpose. The RP must ensure that they receive from DSD Build, who carried out the works, the certificate of conformity stating products used, location and fire rating of materials.	3	B

- At the time of the Assessment the Assessor assessed various areas to ensure that the fire compartmentation was adequate and fit for purpose. However, the Assessor noted where cables pass through a ceiling (fire resisting construction) which had not been adequately fire stopped above the main electrical intake within the storerooms. Due to the building being flats, it places greater importance on ensuring that the fire resisting construction / compartments have not been compromised and are fit for purpose. Please note that pink/yellow or blue expanding foam is not deemed fit for purpose. The RP must ensure that a competent person fire stops these areas with the correct fire rated product. Please note that when a contractor carries out any work the RP should ensure that they receive a certificate of conformity of the type of products used. Please note that the current product in use (pink expanding foam) would be deemed not fit for purpose. The RP must ensure that they receive from DSD Build, who carried out the works, the certificate of conformity stating products used, location and fire rating of materials.

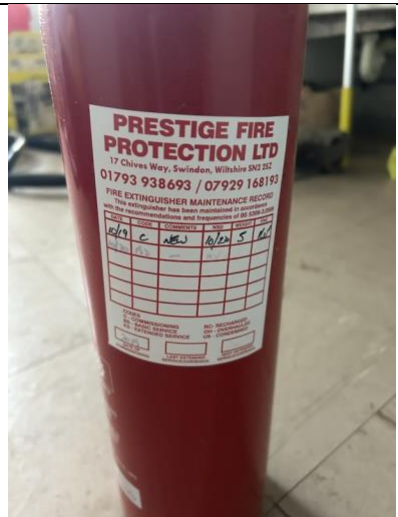
Action required & Ongoing monitoring		
16	The two installed fire extinguishers were last serviced by Prestige Fire Protection in October 2020 and therefore outside their annual service date. If they remain, not advised, the RP must ensure that there are inspected annually by a competent person.	3	C

29.4	Is annual maintenance of fire extinguishing appliances undertaken? Comments and deficiencies observed:		X	
	<ul style="list-style-type: none"> The two installed fire extinguishers were last serviced by Prestige Fire Protection in October 2020 and therefore outside their annual service date. If they remain, not advised, the RP must ensure that there are inspected annually by a competent person.

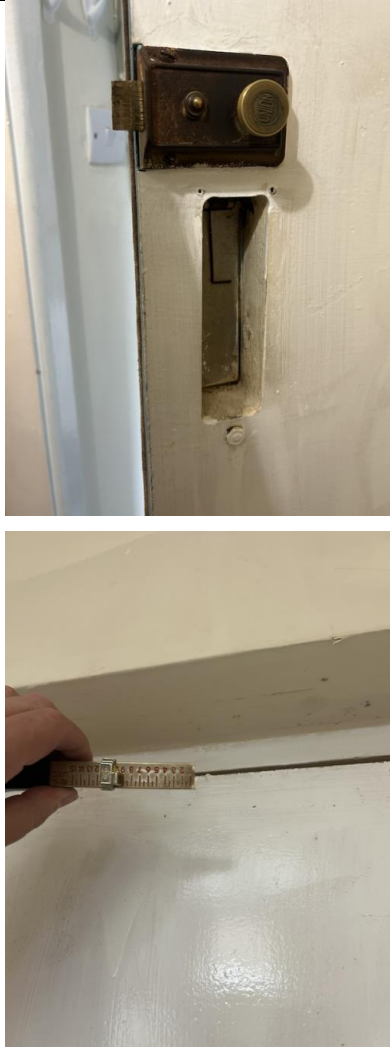
No	Significant Findings & Required Action	Priorities	Timescale	Photo
17	In accordance with BS 5839 part 1 the fire alarm systems must be tested by a competent person at least every six months and an audible weekly operation of the fire alarm (via a different call point on rotation) being conducted by the end user. At the time of the Assessment and advised via email it was noted that TH White carry out all tests on the fire alarm system.	O	Weekly & Every 6 months	No Photo
		Ongoing maintenance		
18	The RP must ensure that that a competent person is testing the Emergency Escape Lighting (EEL) system annually and that the RP ensures that the end user monthly test is being conducted in accordance with BS 5266. Via email the Assessor was informed that TH White carry this out on behalf of the RP. Plus, in the logbook there were some records.	O	Monthly & Annually	No Photo
		Ongoing maintenance		
19	The RP must ensure that each flat entrance and common areas fire doors are fit for purpose and are being inspected every 12 months in accordance with the Fire Safety (England) Regulation 22. And are fit for purpose as per BS 8214:2016 or manufactures instruction. It is of high importance for these inspections to ensure that a good standard of fire safety is maintained within the means of escape. At the time of the Assessment Flats 16 & 22 entrance doors were fully inspected and common fire doors were assessed. The RP must ensure that they notify leaseholders/residents to have their flat entrance fire doors inspected and inform the RP of the condition of their fire doors. The RP and the leaseholders, where necessary, must ensure the fire door remediations works within the reports are completed within a defined timeframe and all fire doors are fit for purpose that open onto the common areas. At the time of the Assessment various fire doors (new and existing) would not perform as intended. Please note too, the person who is carrying out the fire doors inspections, must be aware as to what is required as part of the end user's inspection responsibilities. There are clear faults with some of the current fire doors, which should have been identified as part of this inspection.	O-2	A

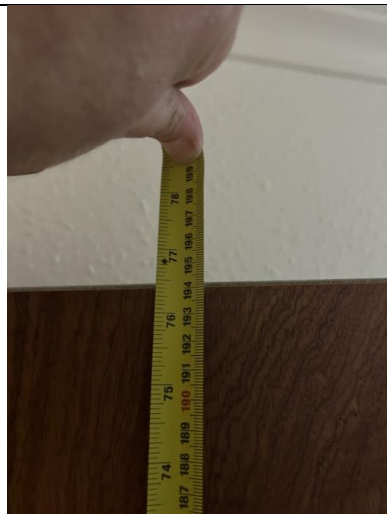
No	Significant Findings & Required Action	Priorities	Timescale	Photo
20	Flat 22 is a new fire door, which has not been installed as per the manufacturer's (Premdor) instructions. The maximum this door leaf can be trimmed is 5mm off the bottom and none off the top edge. However, this door was originally 1981mm in height and has been cut down to a height of 1940mm. Therefore, this fire door would not perform as intended and is not a FD30S Premdor C380 6881A581 certified fire door because of this. Please note the Assessor has contacted Premdor the manufacturer who has confirmed this too. The RP must ensure they contact DSD Build if they installed this fire door. Or the leaseholder and ensure that this fire door is replaced with a certified FD30S fire door and being installed by a competent person in accordance with the manufacturer's instructions. Also, the RP must ensure all other fire doors which have been installed are fit for purpose, which is not the case at present with fire doors observed.	O-2	A

Summary & Recommendations:					
Fire Door Fails Inspection – Medium Risk – Action Required					
<p>Flat 22 is a new fire door, which has not been installed as per the manufacturer's (Premdor) instructions. The maximum this door leaf can be trimmed is 5mm off the bottom and none off the top edge. However, this door was originally 1981mm in height and has been cut down to a height of 1940mm. Therefore, this fire door would not perform as intended and is not a FD30S Premdor C380 6881A581 certified fire door because of this. Please note the Assessor has contacted Premdor the manufacturer who has confirmed this too. The RP must ensure they contact DSD Build if they installed this fire door. Or the leaseholder and ensure that this fire door is replaced with a certified FD30S fire door and being installed by a competent person in accordance with the manufacturer's instructions. Also, the RP must ensure all other fire doors which have been installed are fit for purpose, which is not the case at present with fire doors observed.</p>

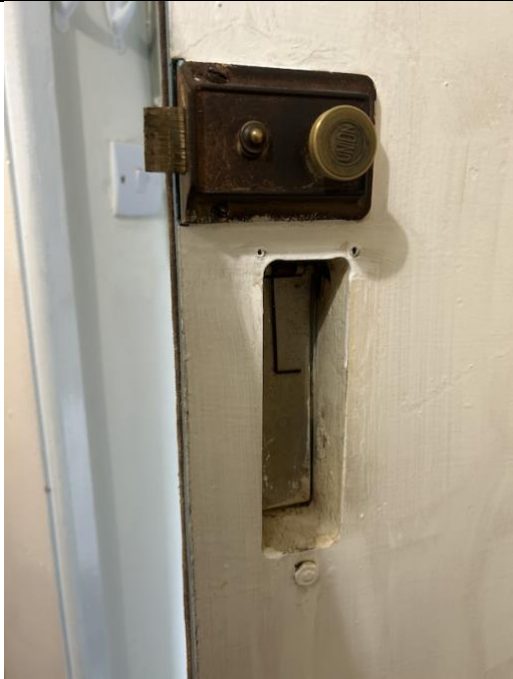
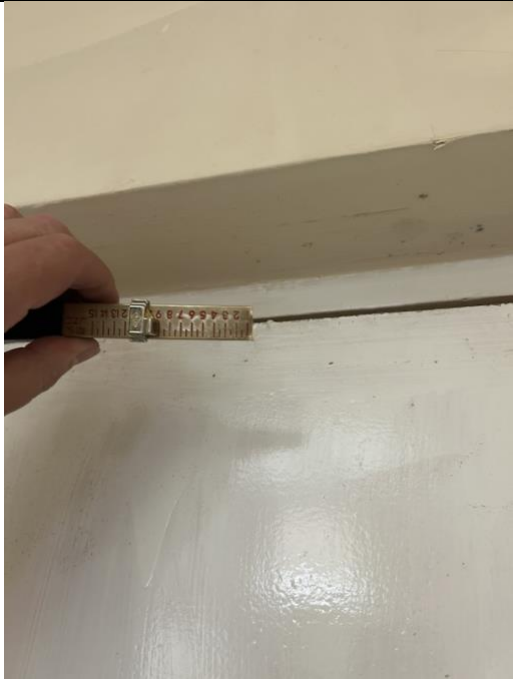
Fire Door Images	Flat 16 Entrance Door Fire Door

Door Label					
Door Reference:		Flat16 Entrance Door Fire Door			
FR:		30 minutes			
Door Set Type:		Single			
Has the fire door got a third-party fire door scheme label or plug fitted?		No label or plug visible			
Door Leaf					
Enter the Height of the door leaf (mm)		1980			
Enter the Width of the door leaf (mm)		745			
Enter the Thickness of the door leaf (mm):		44			
Does the door leaf sit against the door stop and is it free from distortion?		Yes			
Is the door free from damage including dents?		Yes			
Door finish type:		Veneered			
Door Signage:		N/A			
Door Frame					
Door frame section size - Width (mm):		753			
Is the door frame firmly attached to the wall?		Yes			
Leaf To Frame Gaps					
Leaf to frame gap – Top Head (mm):		Left – Middle - Right	8	9	10
Leaf to frame gap - Closing Edge (mm):		Top – Middle – Bottom	6	6	6
Leaf to frame gap - Hinge Edge (mm):		Top – Middle - Bottom	1	2	2
Leaf to frame gap - Sill (mm):		Left – Middle - Right	1	1	1

Intumescent/Smoke/Acoustic Seals					
Are intumescent seals in place?		Yes			
Are the seals free from damage?		Yes			
Seal Type:		Intumescent & Cold smoke			
Seal Size (mm):		12			
Are the seals well attached inside the rebate of the frame or door leaf?		Door			
Are the seals continuous around the frame or door?		Yes			
Are the seals Interrupted?		Yes, hinge & lock areas			
Hinges					
Are there a minimum of 3 hinges fitted?		Yes			
Have the hinges been bedded on or bypassed with a suitable fire protection material?		No			
Hinge Type:		CE fire rated			
Are the hinges free from metal fragments and oil leakage, which are signs of wear?		Yes			
Door Closers					
Does the door have a closer?		Yes			
Open the door to 5 degrees or 75mm. Does it close and engage with the latch?		Yes			
Is the self-closer fire rated		CE fire rated			
Is the closer correctly attached to the door and frame?		Yes			
Is the closer free from damage and not leaking?		Yes

If unlatched, does the closer hold the door in line with the frame and intumescent seal?		Yes			
Hold Open Devices					
Does the door have an electronically powered hold open device?		N/A			
Lock And Latch					
Does the door have a certified lock and/or latch?		None fire rated lock and furniture			
Is a door selector fitted?		N/A			
Glazing And Glass					
Does the door leaf contain a vision panel(s)?		No			
Is the edge protection on both sides of the glass?		N/A			
Is the intumescent continuous to the glass and bead?		N/A			
Is the beading hardwood timber?		N/A			
Is the glass free from damage and cracking?		N/A			
What is the type of glass in the vision panel?		N/A			
Is the area of the glass present within the maximum size specified by the manufacturer?		N/A			
Spy hole & Letter plates					
Is a spy hole installed?		No			
Is a letter plate installed and fire rated?		Yes & none fire rated (middle of door)

Summary & Recommendations:					
<p>Fire Door Fails Inspection – Medium Risk – Action Required</p> <p>Replace installed door lock & latch with CE Approved BS EN 12209 fire rated door lock latch.</p> <p>Install CE fire rated letterbox and plate with BS EN 1634-1 & BS EN 13724 with intumescent lining and a cold smoke seal fitted.</p> <p>Adjust or rehang fire door so that gaps between fire door and doorframe are 2-4mm maximum.</p> <p>Install threshold dropdown intumescent strip combined smoke seal with 30-minute fire rating.</p>

This fire door doorset must be installed, repaired and maintained in accordance with BS 8214:12016 by a competent person and or the manufacturer's instructions and once all remedial works are completed will be defined as a Notional 30-minute FD30S fire door.
