Fire Door Inspection

Fire Door Inspection Marlborough Court

Marlborough Court, Royal Wootton Bassett, SN4 8HG

04.09.2025 15:00 BST

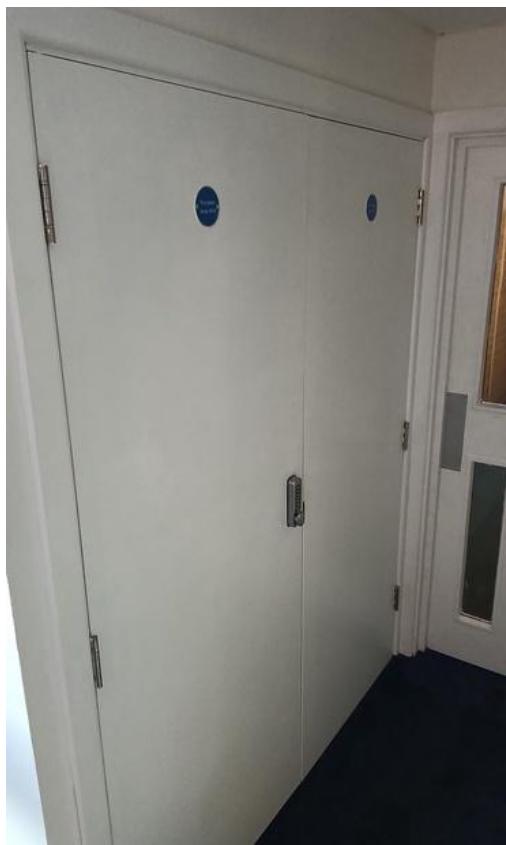
Photo 1

Double fire doors in ground floor entrance foyer

FD30

| Compliance Rating | Compliant |

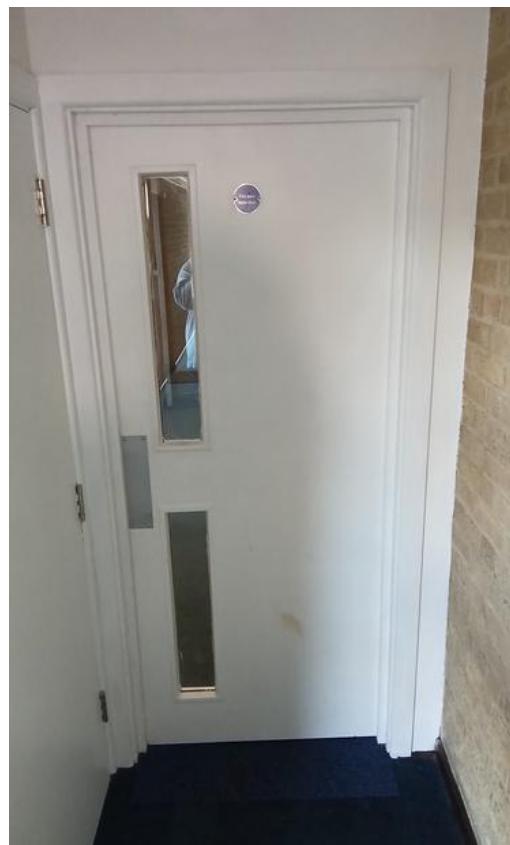
Photo 2

Single corridor fire door leading left from ground floor foyer.

| FD Rating | FD30 |

| Compliance Rating | Compliant |
